**RCRA/TSCA CLEANUP PLAN  
For BASF SITE  
CRANSTON, RHODE ISLAND**

**Presented to: U.S. EPA Region 1, Boston, MA  
April 4, 2017**

**By: Joseph Guarnaccia, PhD, BASF;  
Stephen Graham, PE, LSP, Senior VP, &  
Richard Kowalski, CPG, CHMM, Senior Project  
Manager, AEI Consultants**

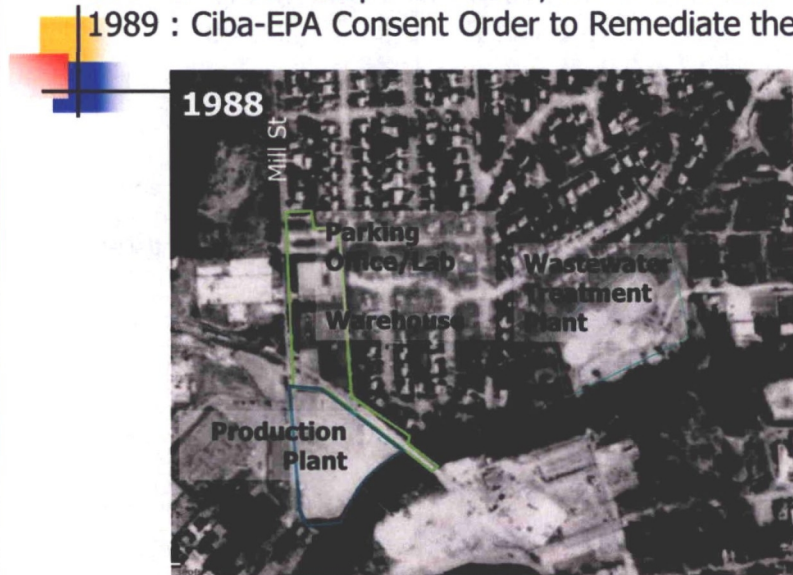
In 1986 Ciba-Geigy ceased all manufacturing processes on the property and began decommissioning and razing the chemical processing facility. There have been no manufacturing operations on any portion of the property since that time.

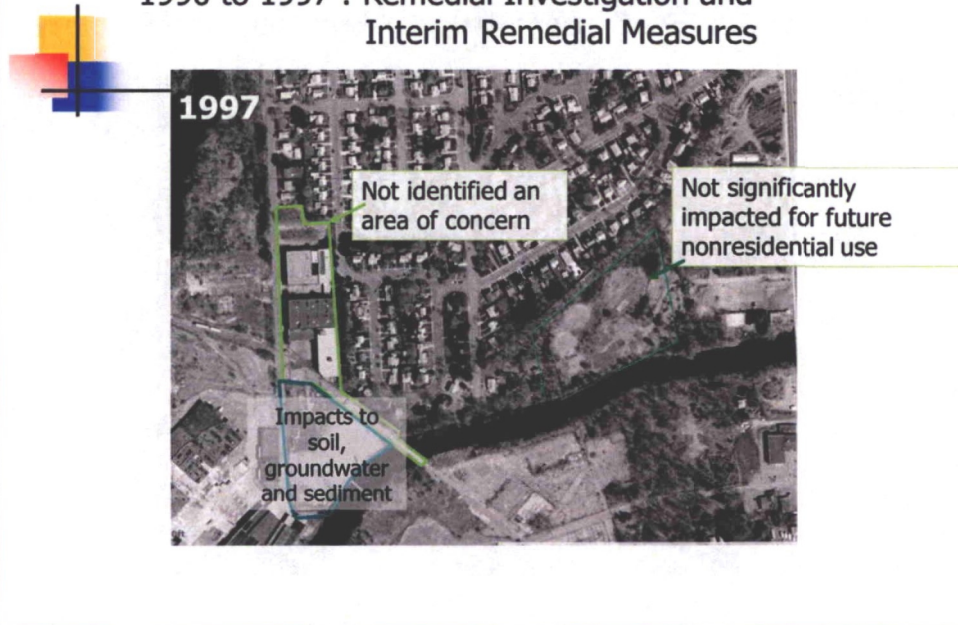
1990 to 1997 : Remedial Investigation and  
Interim Remedial Measures

From 1990 to 1997, with EPA oversight, Ciba-Geigy conducted several remedial investigations, and by 1996 it had implemented several required remedies on the former production facility River Lot, called interim remedial measures (IRMs), including removing and capping facility-affected surface soils and sediment and removing and controlling groundwater impacted with industrial solvents. No issues were identified on the Building Lot to warrant remedial action.

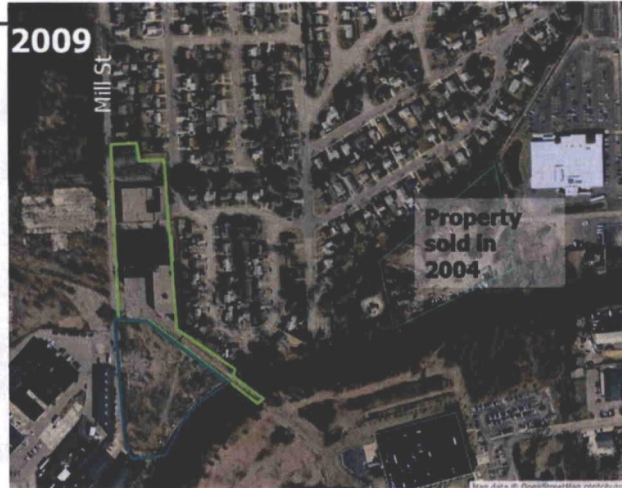
Operation of a P&T system with monitoring to inform protectiveness and restoration.

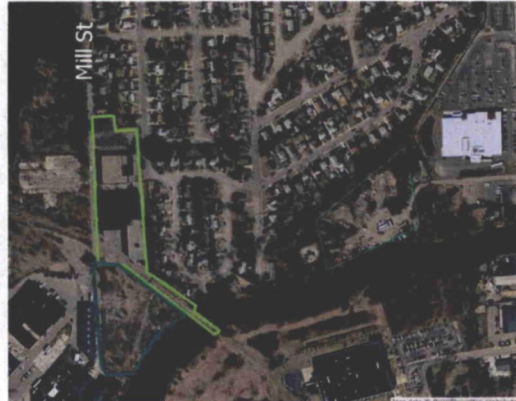
Because BASF only acquired the property in 2009 and did not control past remedial efforts, it began its ownership tenure by verifying and further assessing current environmental site conditions. The goal was to fully evaluate the IRMs and determine the need for additional remedial actions to complete the RCRA project requirements and put the property back to productive use in the community. To this end, from 2011 to 2015, BASF conducted document review and field investigation tasks to validate IRM need and effectiveness, and develop a remediation plan. Investigation tasks included several rounds of soil, groundwater and sediment data collection and analysis. The results were documented in the Supplemental Remedial Investigation (SRI) Report (2014).

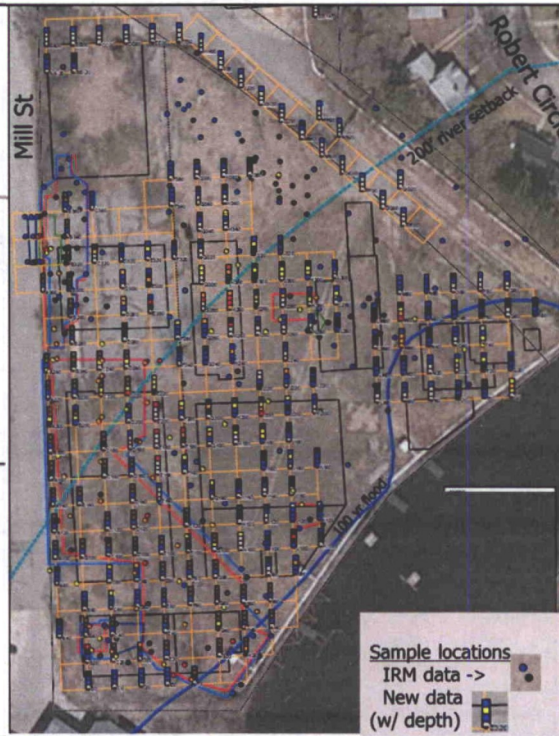
## Soil Investigations

Basis for PCB characterization

- 1995 RFI data to 1' BGS
- IRM, 4 excavation phases
- IRM post-x samples
- BASF SIR gridded samples, 3 phases, to 6' BGS.

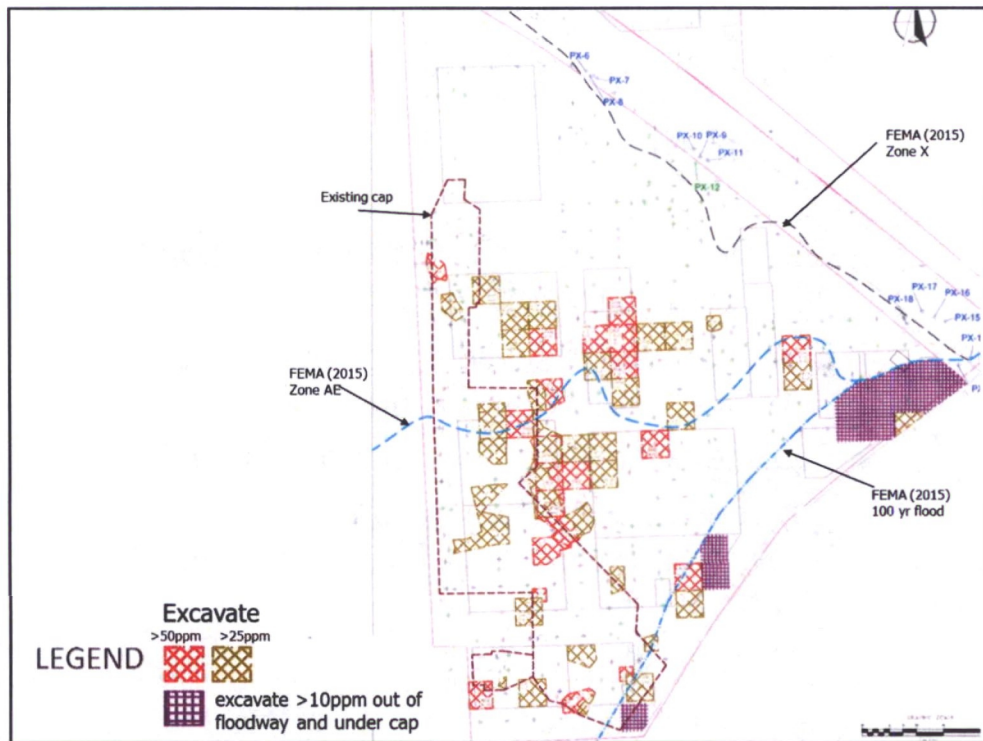
## RIDEM Cap Requirements

(for PCBs >10 ppm to remain in place)

- 4-inches of Asphalt/Concrete, or
- 6-inches of Gravel, or
- 12-inches of Clean Fill Over a Geotextile Layer, or
- 24-inches of Clean Fill

- Remove PCBs found > 50 ppm regardless of depth, and PCBs > 25 ppm < 50 ppm to 2 ft below existing grade (Resulting excavation: ~ 1,700 tons; Actual quantity per post-ex sampling).
- Relocate remaining PCBs > 10 ppm at depths less than 2 ft below grade within Floodway to proposed Cap Area
- Relocate remaining PCBs < 25 ppm @ 0-1 ft depths in Zone AE to Capped Area or Deeper AE Excavation Areas
- Install Up to 2 ft of Clean Fill Cap (may be thinner in some areas due to concrete slabs) to Meet RIDEM Requirements
- Install Fencing
- Place a RIDEM ELUR on Property (to be maintained by BASF)
